LIBBY ASBESTOS PROJECT Supplemental Interior Inspection Checklist (SIIC)

Field Logbook No.: 100348 Page No.: 130 Site Visit Date: 1-5-05
Address: 116 E. Missiona Structure Description: Building
Occupant: Troy High School Phone Number: 295-4606
Owner (If different than occupant): Lincoln County Phone Number:
Investigation Team: B. Shoup, T. Vanducweel
SIIC Check Completed by (100% of forms): B. Shoup

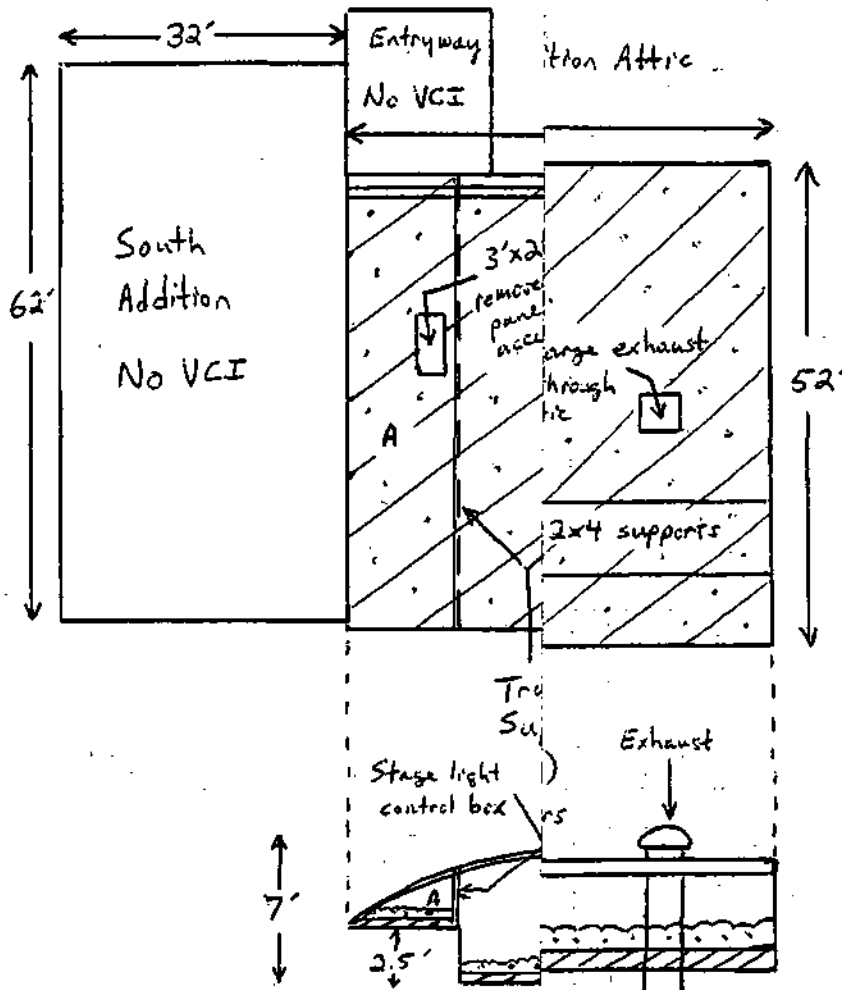
Profile, E-W, of Auditorium ceiling by appx. 8" of blown-in fiberglass. is directly above the stage; it is appx. 1' up. There is plenty of head space.

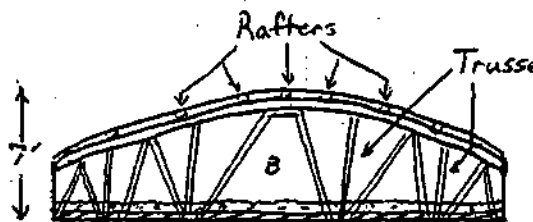
12" of VCI overlain by appx. 12" of blown-in are also vertical 2x4 supports running a tight fit between the 2x4 supports.
